Department of Neighborhood Services Façade Report Application

Address of Building: 901 North 9th Street TaxKey 3910103110

Date of the Report: November 30th, 2016 Occupancy of Building: Assembly - Courthouse

Name: Todd A. Gorrell, R.A. Firm Name: Klein and Hoffman, Inc.

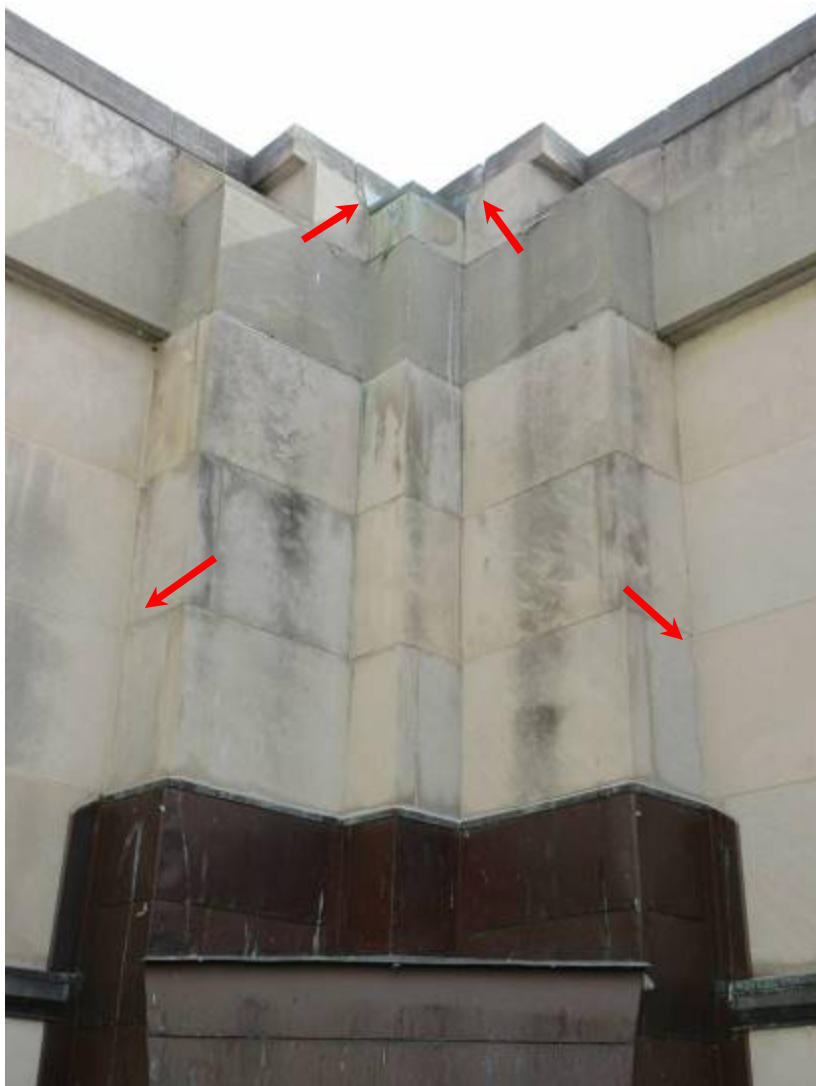
Photo No. 51 Multiple spalls and cracks were observed at the sixth floor northeast corner parapet.

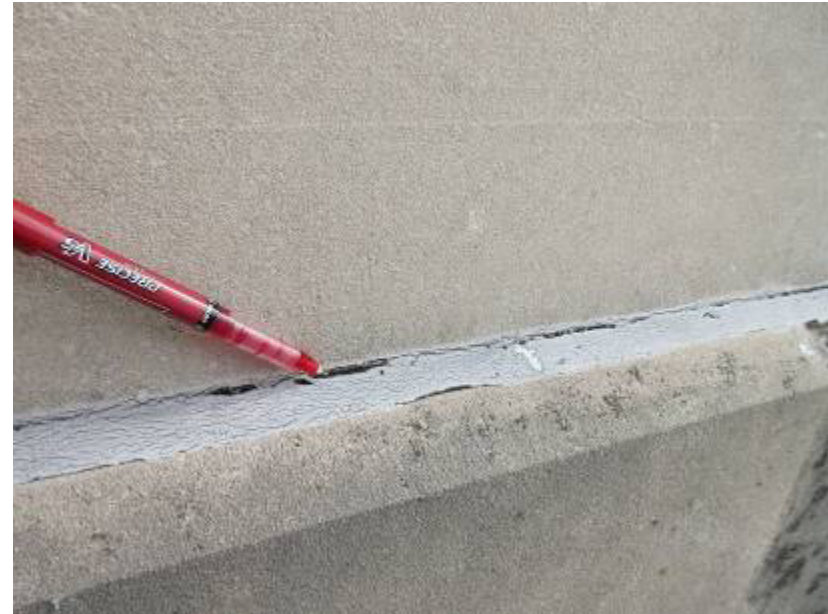
Photo No. 54 Showing failed sealant joint at north seventh floor
parapet.

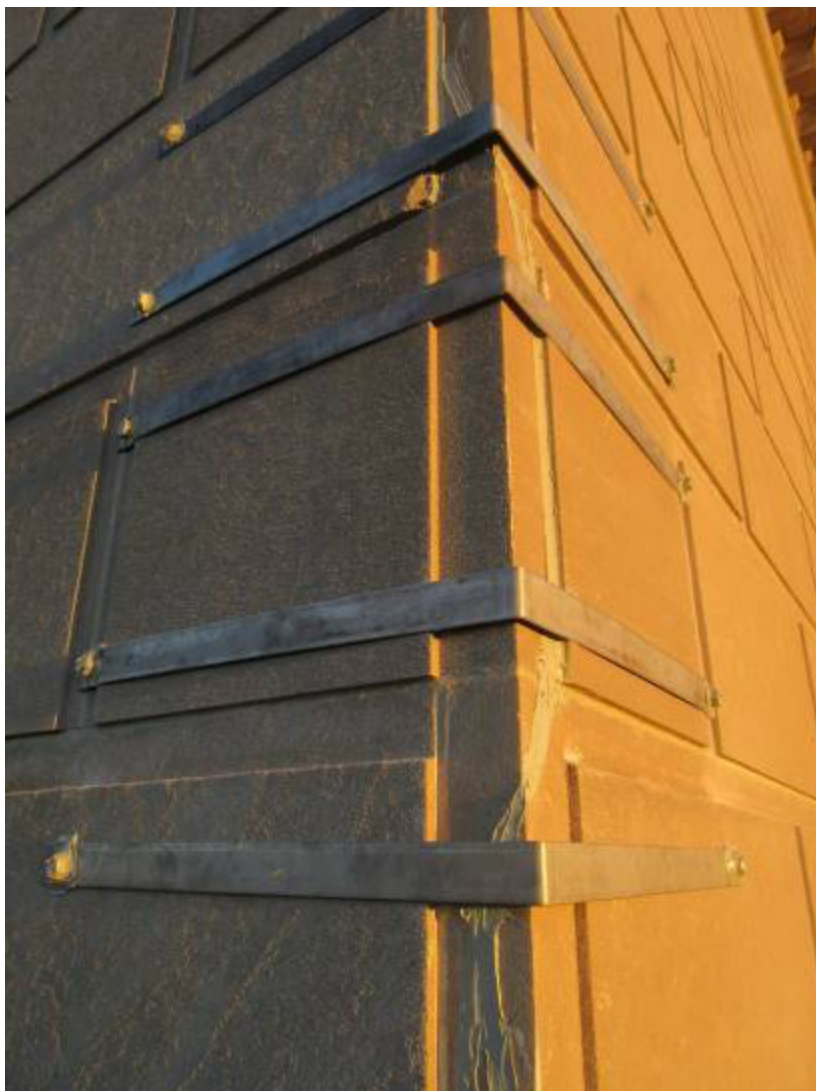
Photo No. 59 Stainless steel straps installed at southeast corner of seventh floor for stabilization of cracked stones.

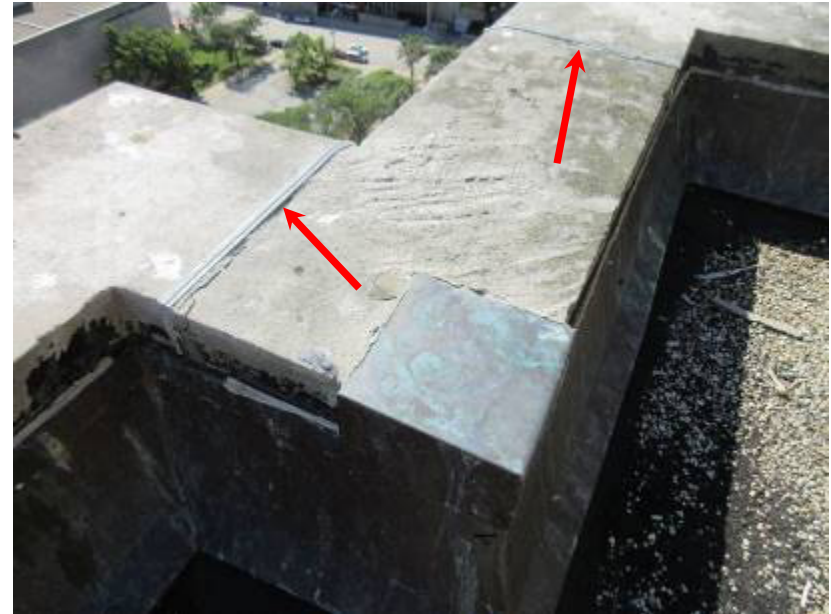
Photo No. 62 Weather cap joint protection installed on the wash joints of the coping stone on Drop #22.

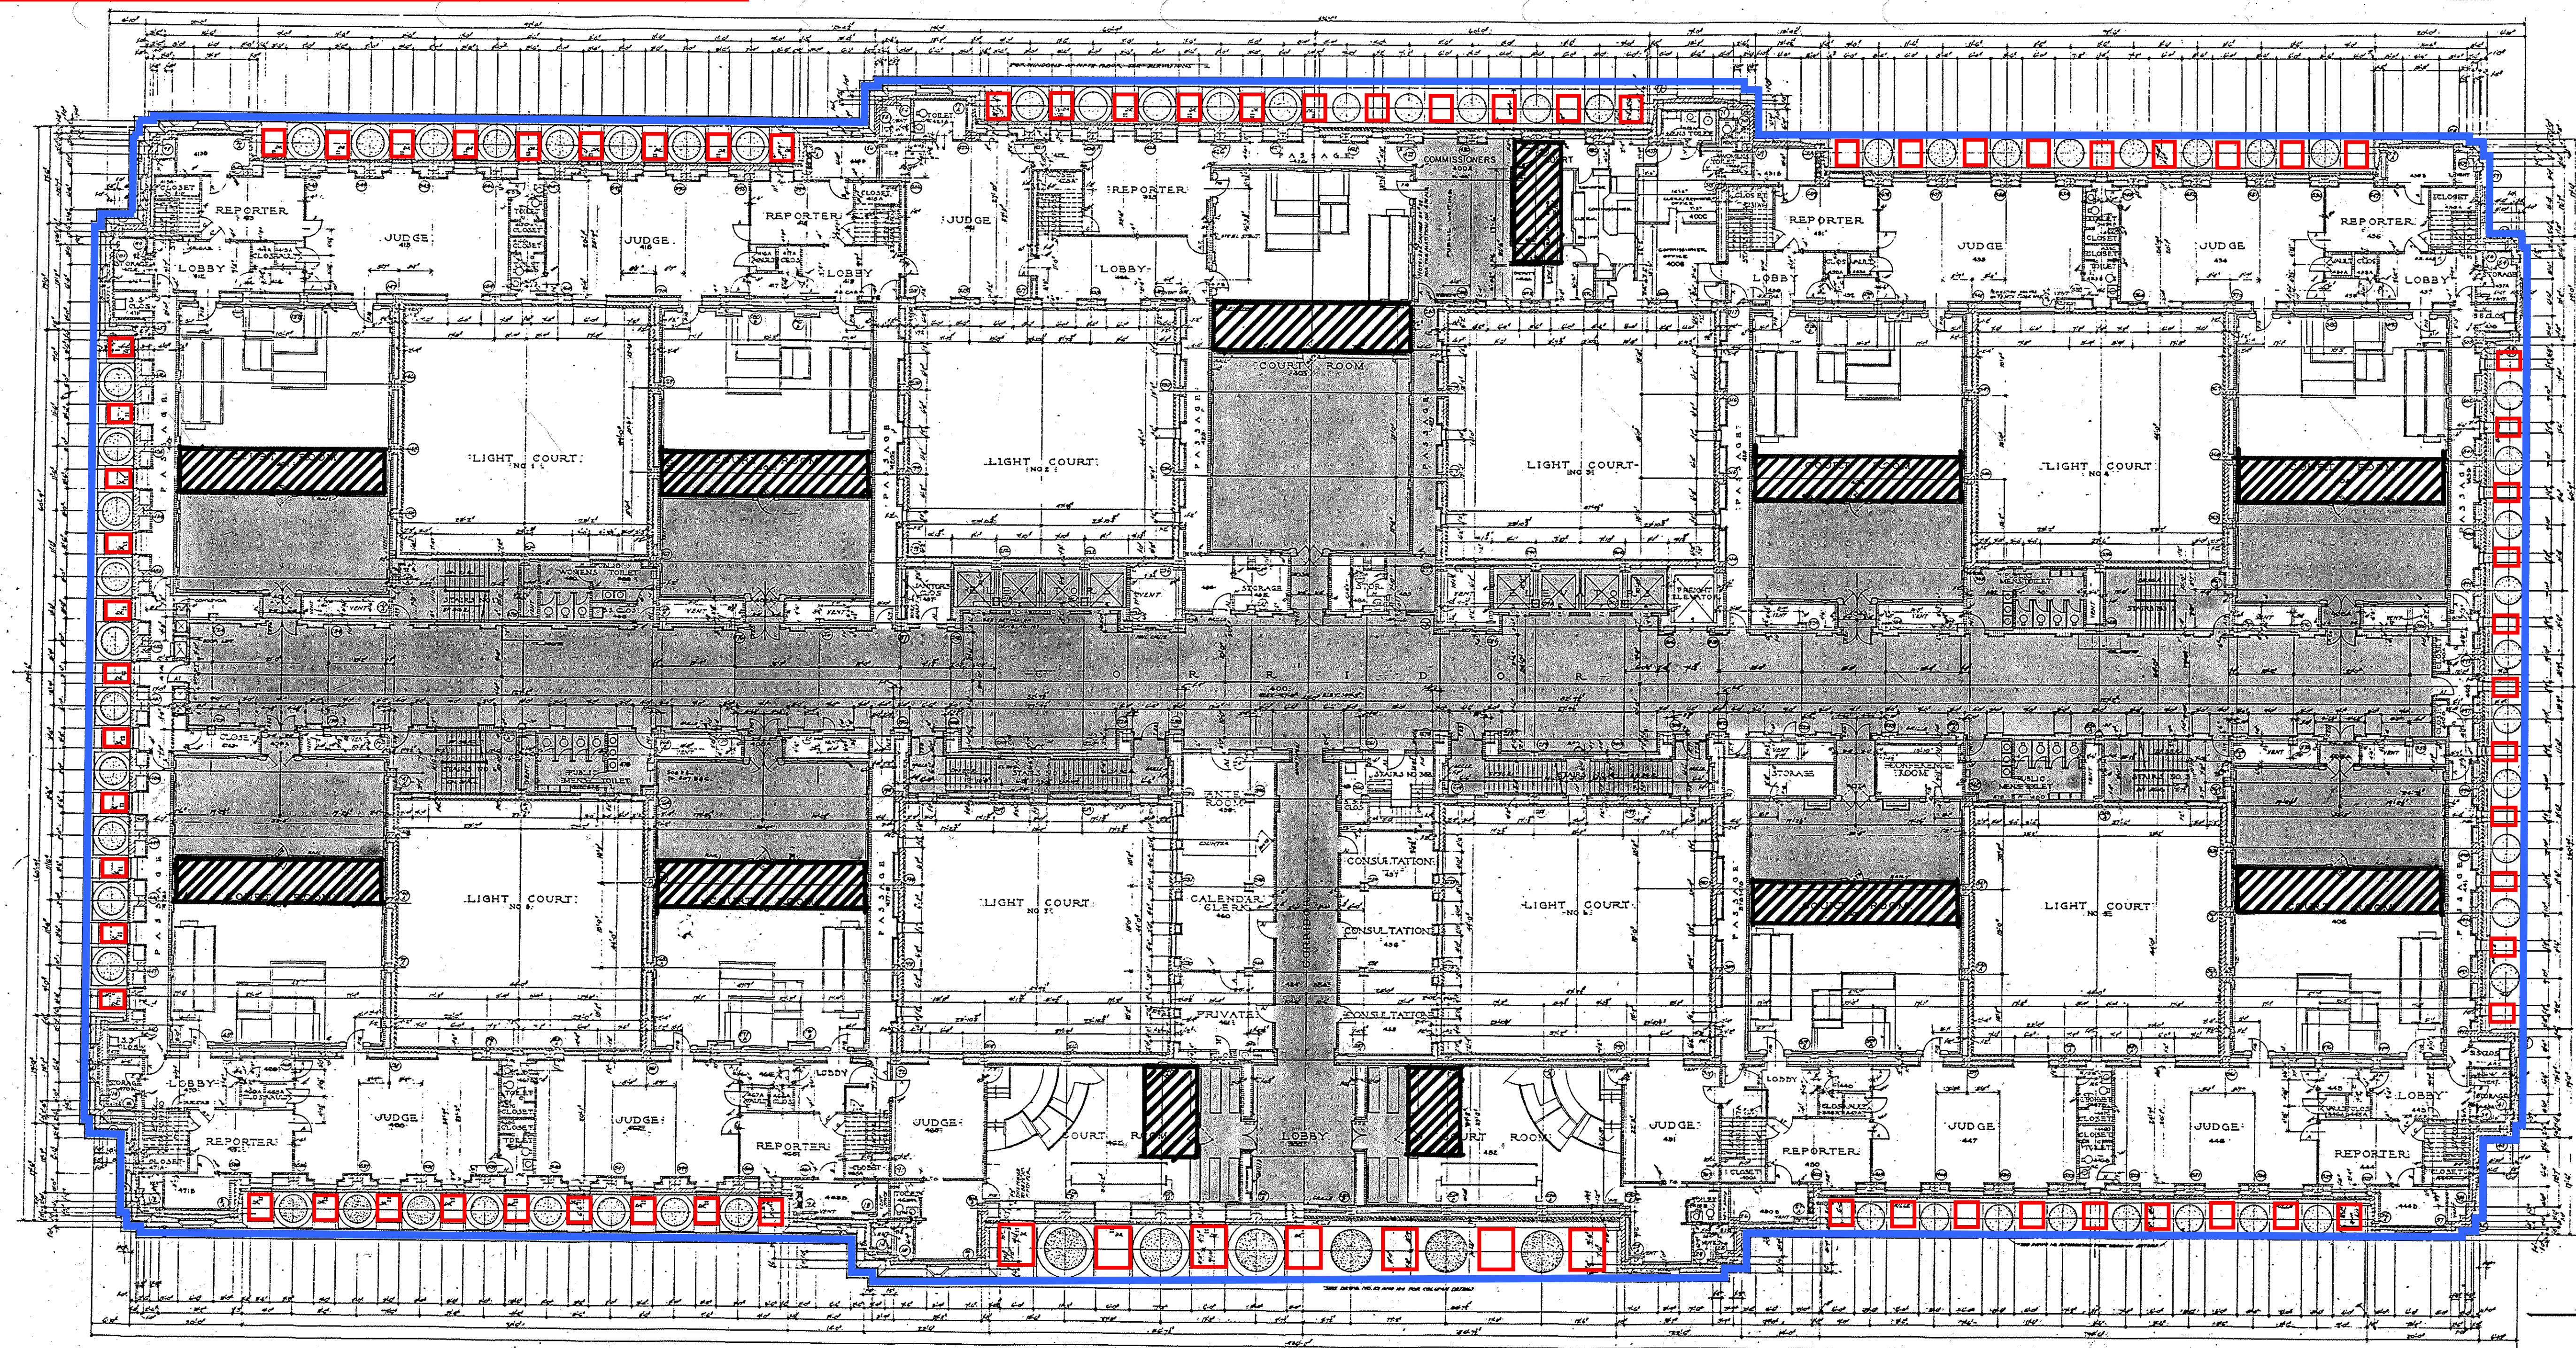
Sealants failed at metal roofing perimeter termination bar. See Photo No. 46

Failed wash joint sealants at parapet copings and back of parapets.

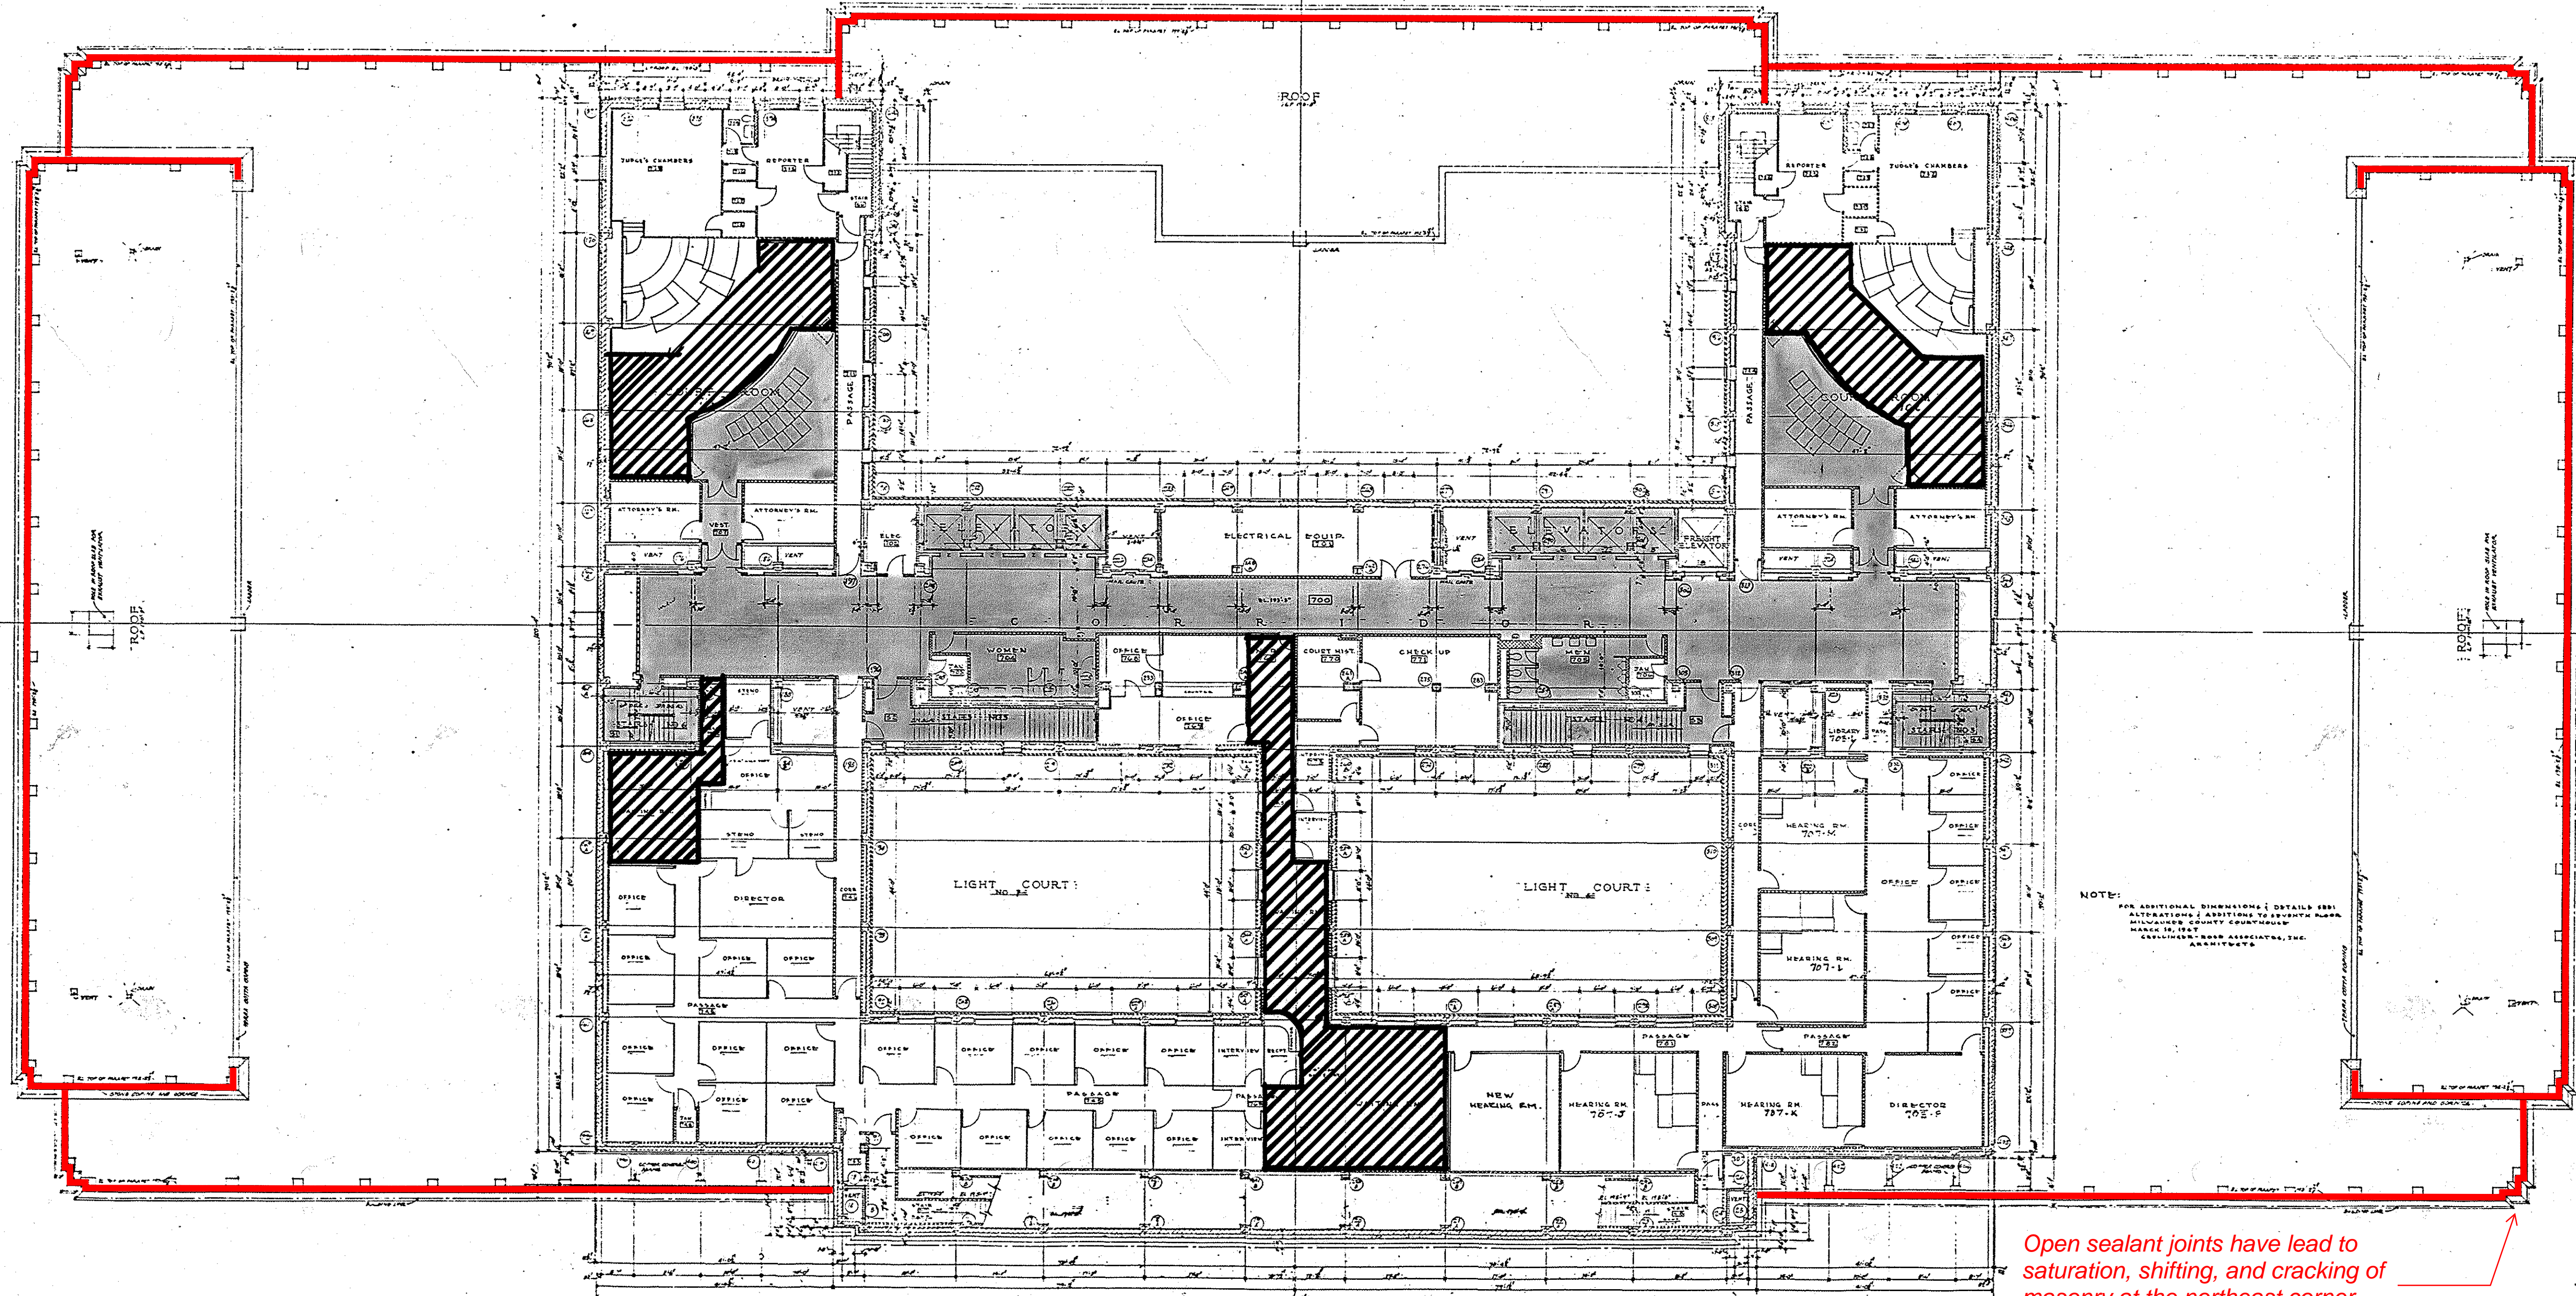
Open sealant joints have lead to saturation, shifting, and cracking of masonry at the northeast corner. See Photo nos. 9 and 60.

Failed wash joint sealants at parapet copings. Sim. to Photo No. 46.

Slight outward displacement and joint separation indicate movement of cornice stones at corner. Sim. to Photo No. 10

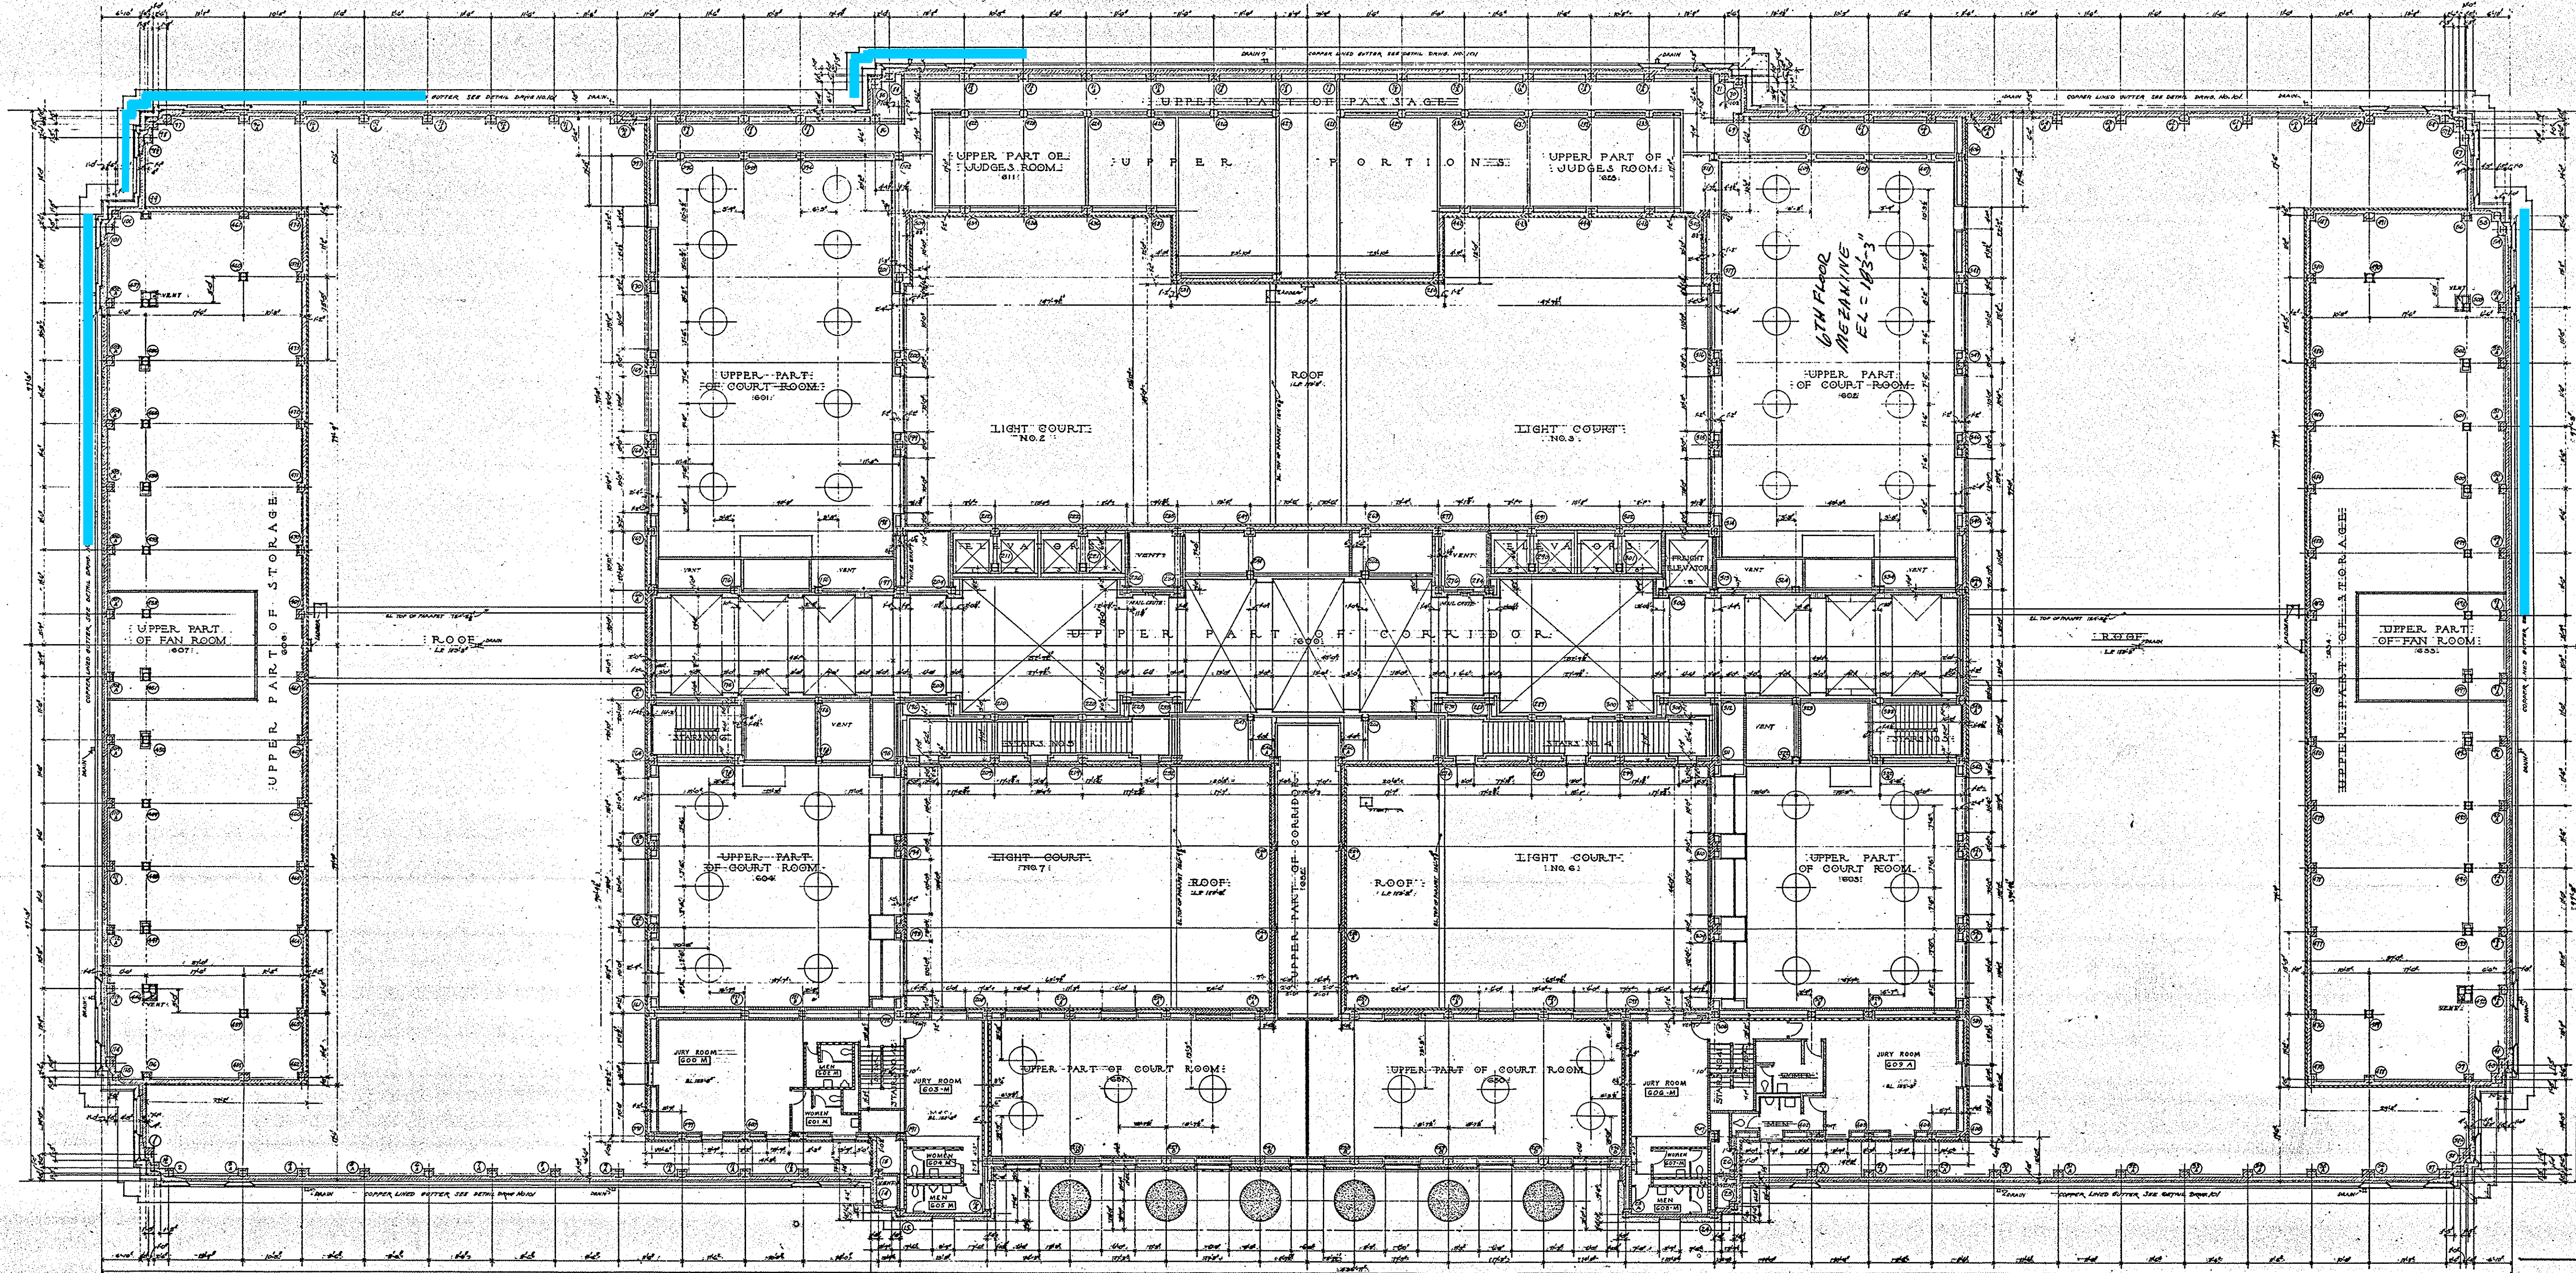
*Ponding water observed at built-in gutter. See Photo No. 45.*
